# **PREVENTION AND CONTROL PLAN FOR THE RAINY SEASON 2024**

# Summary

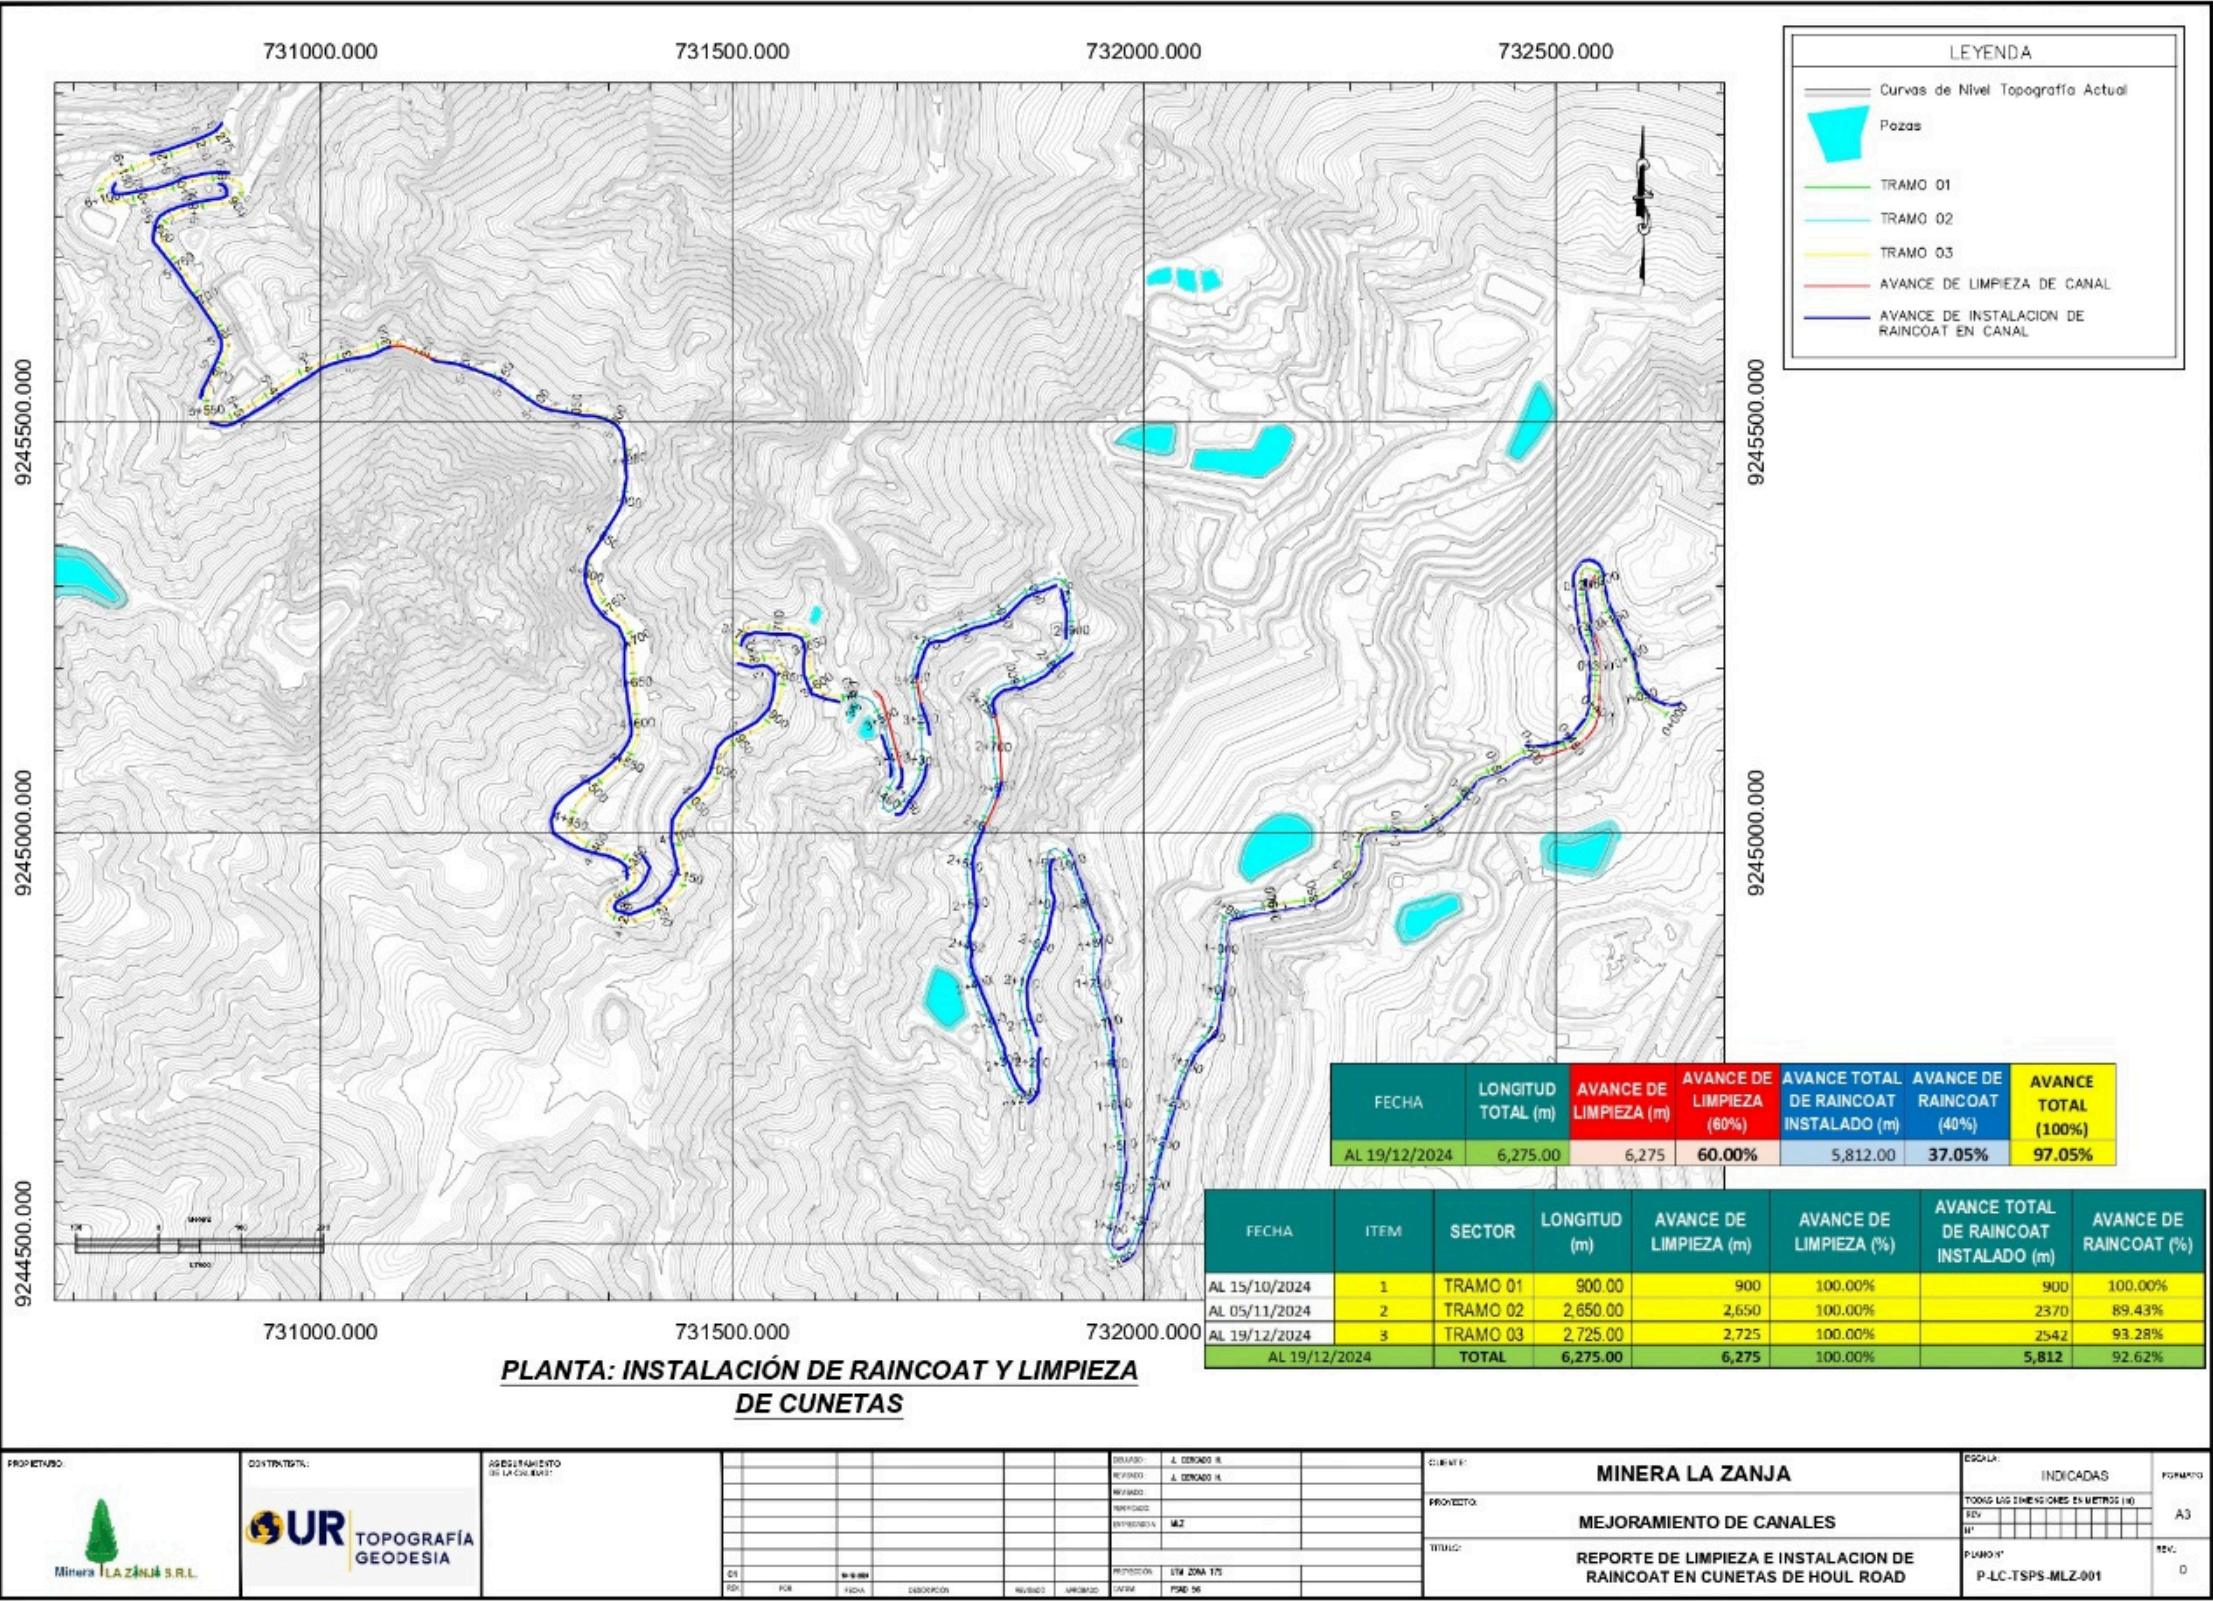
Channel lining with geomembrane.

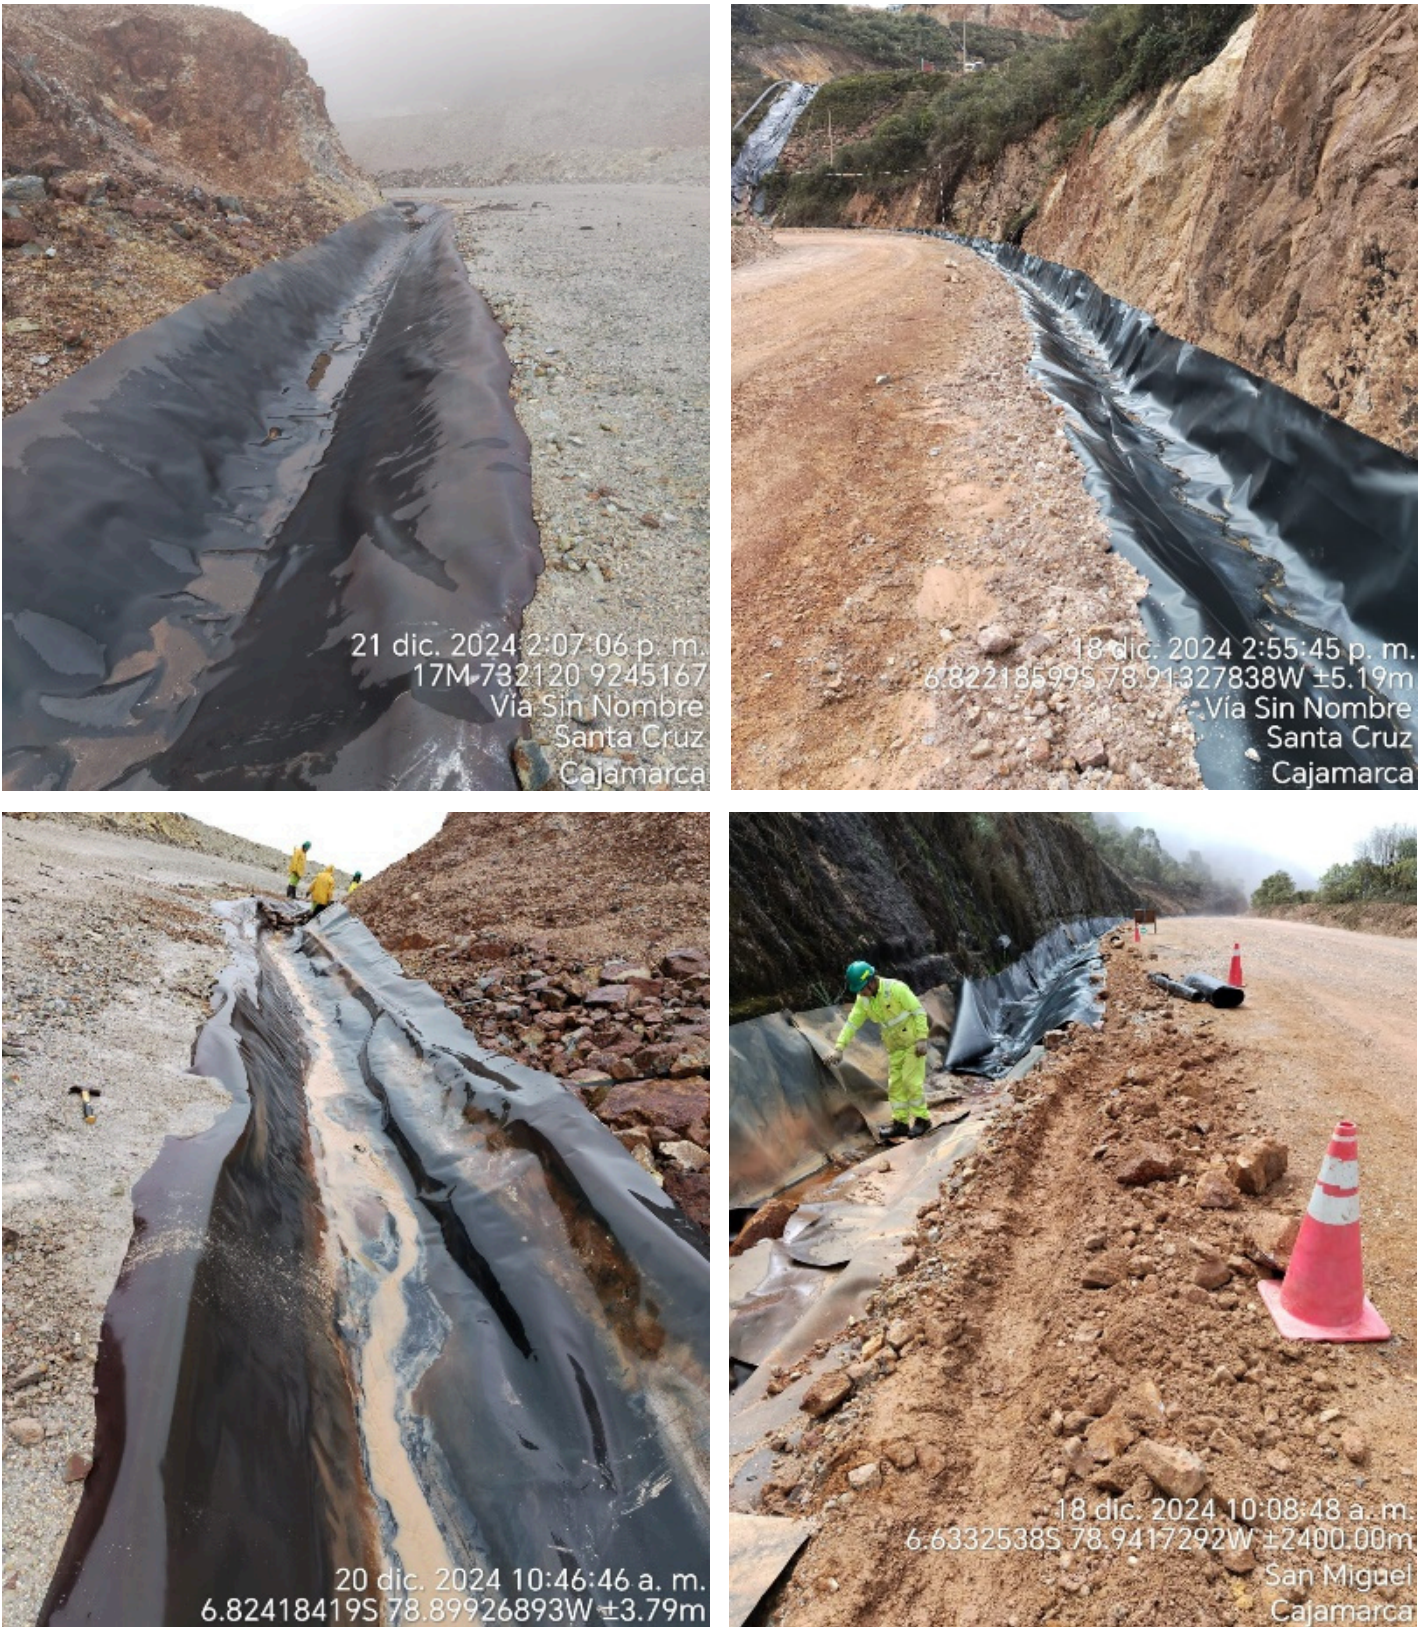
Progress of channel lining with geomembrane

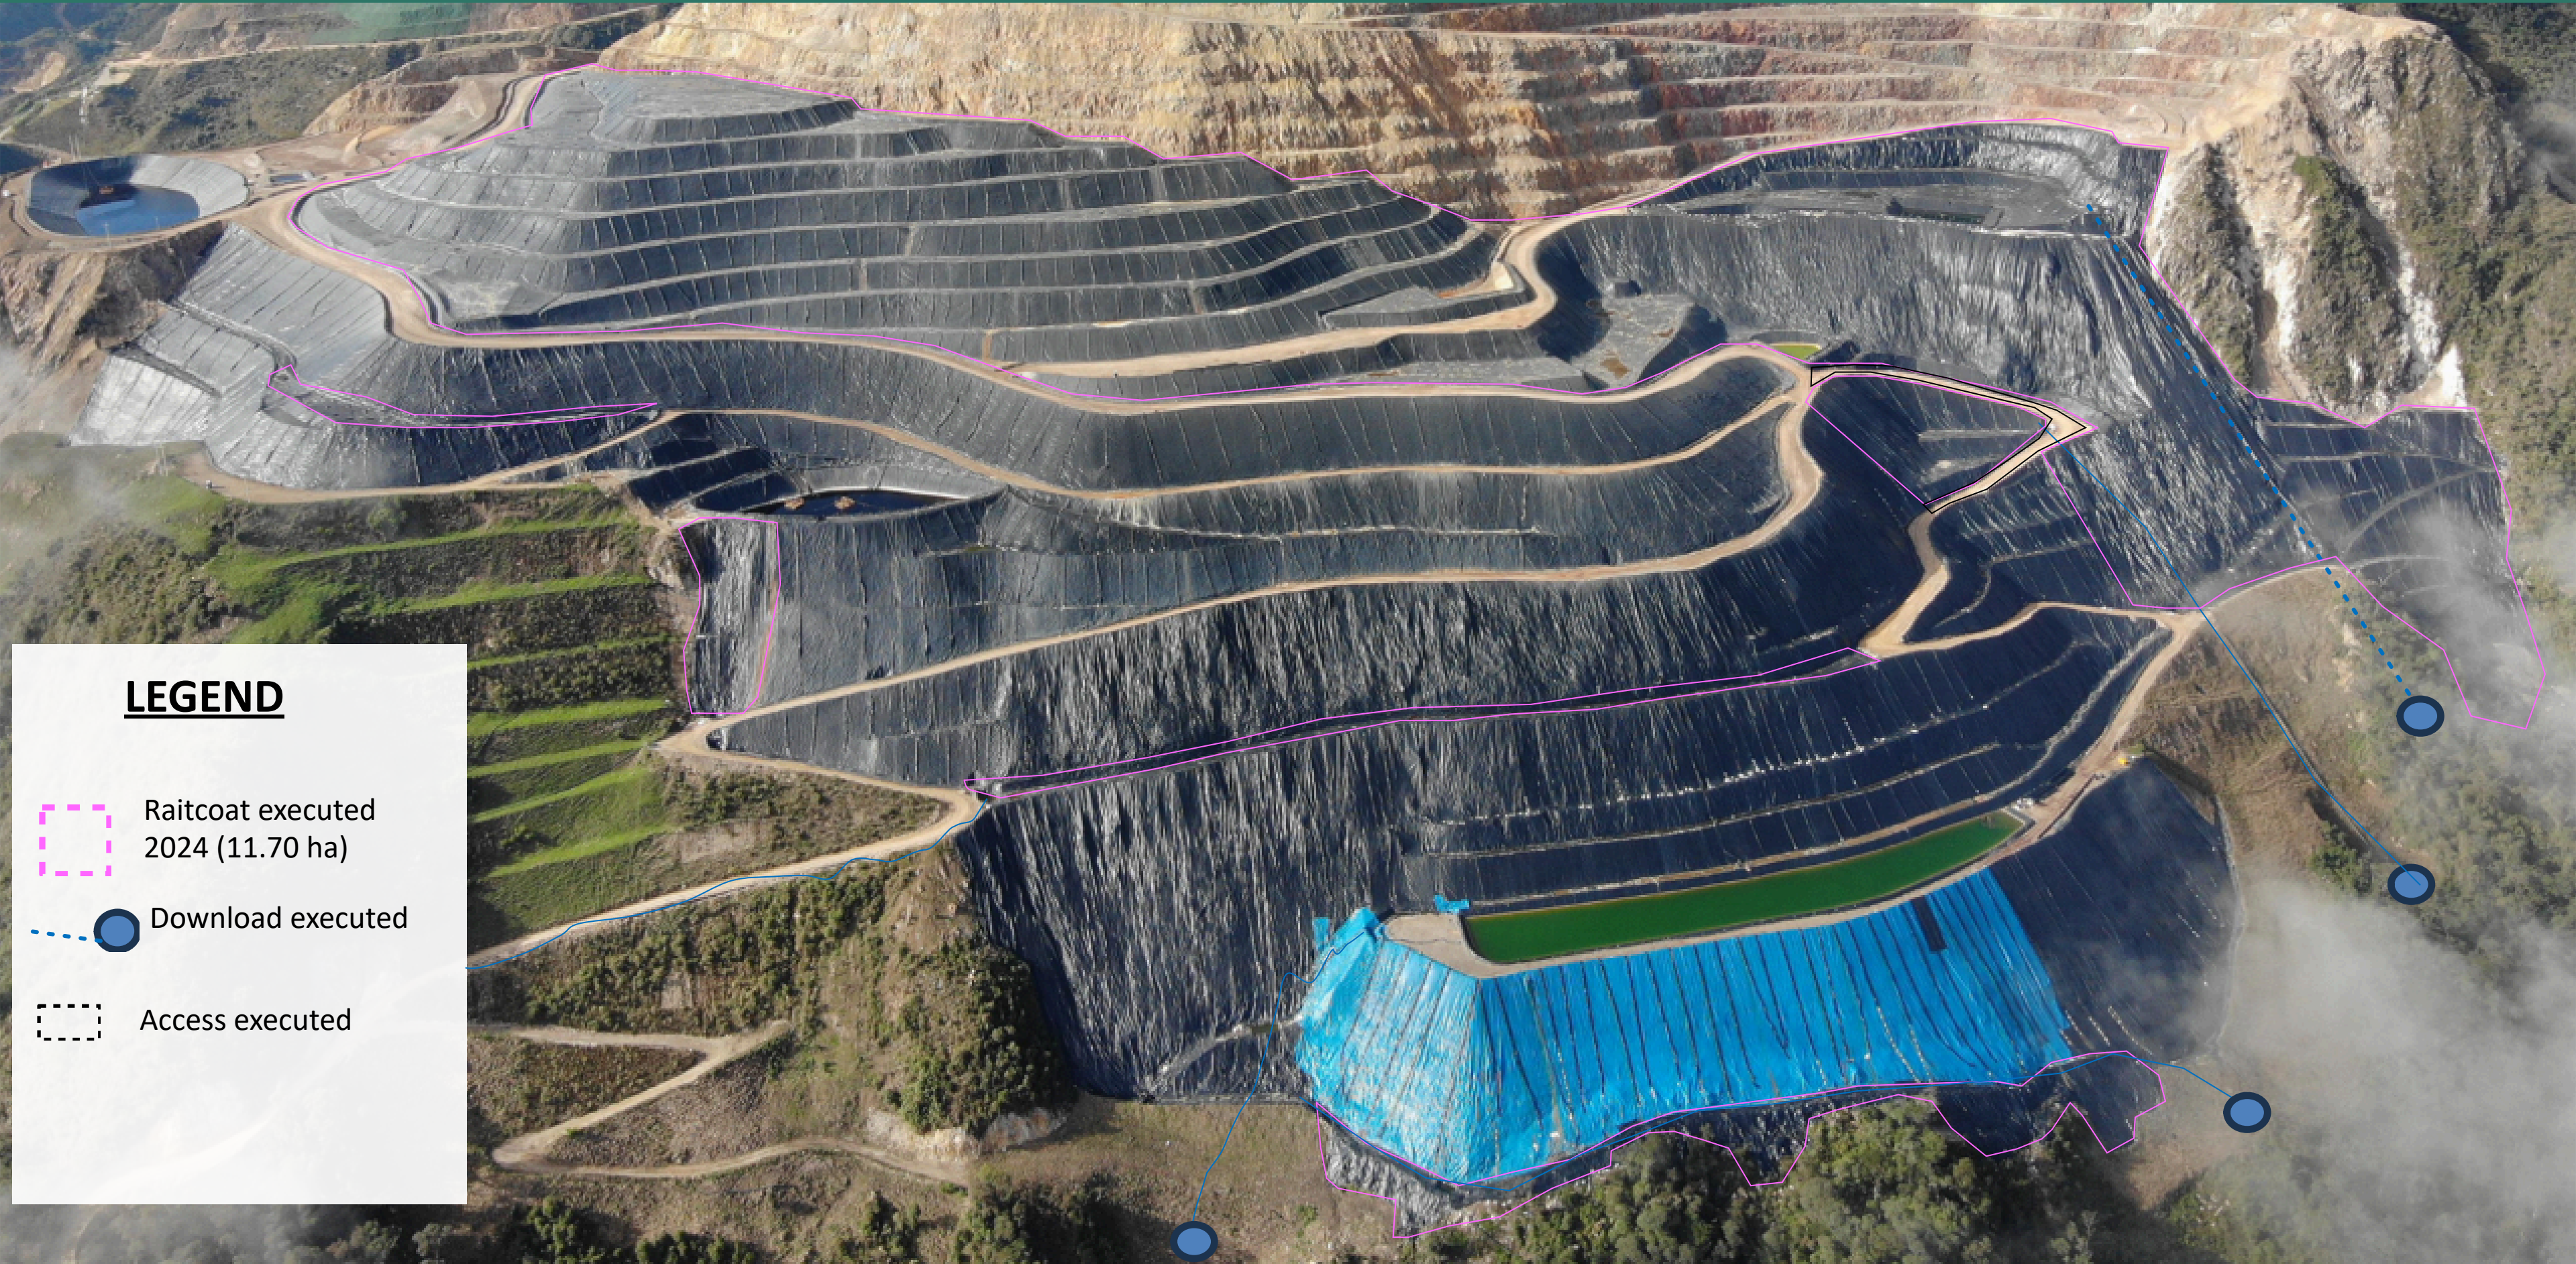
Pampa Verde Lined Raincoat

Raitcoat executed 2024 (11.70 ha)
-

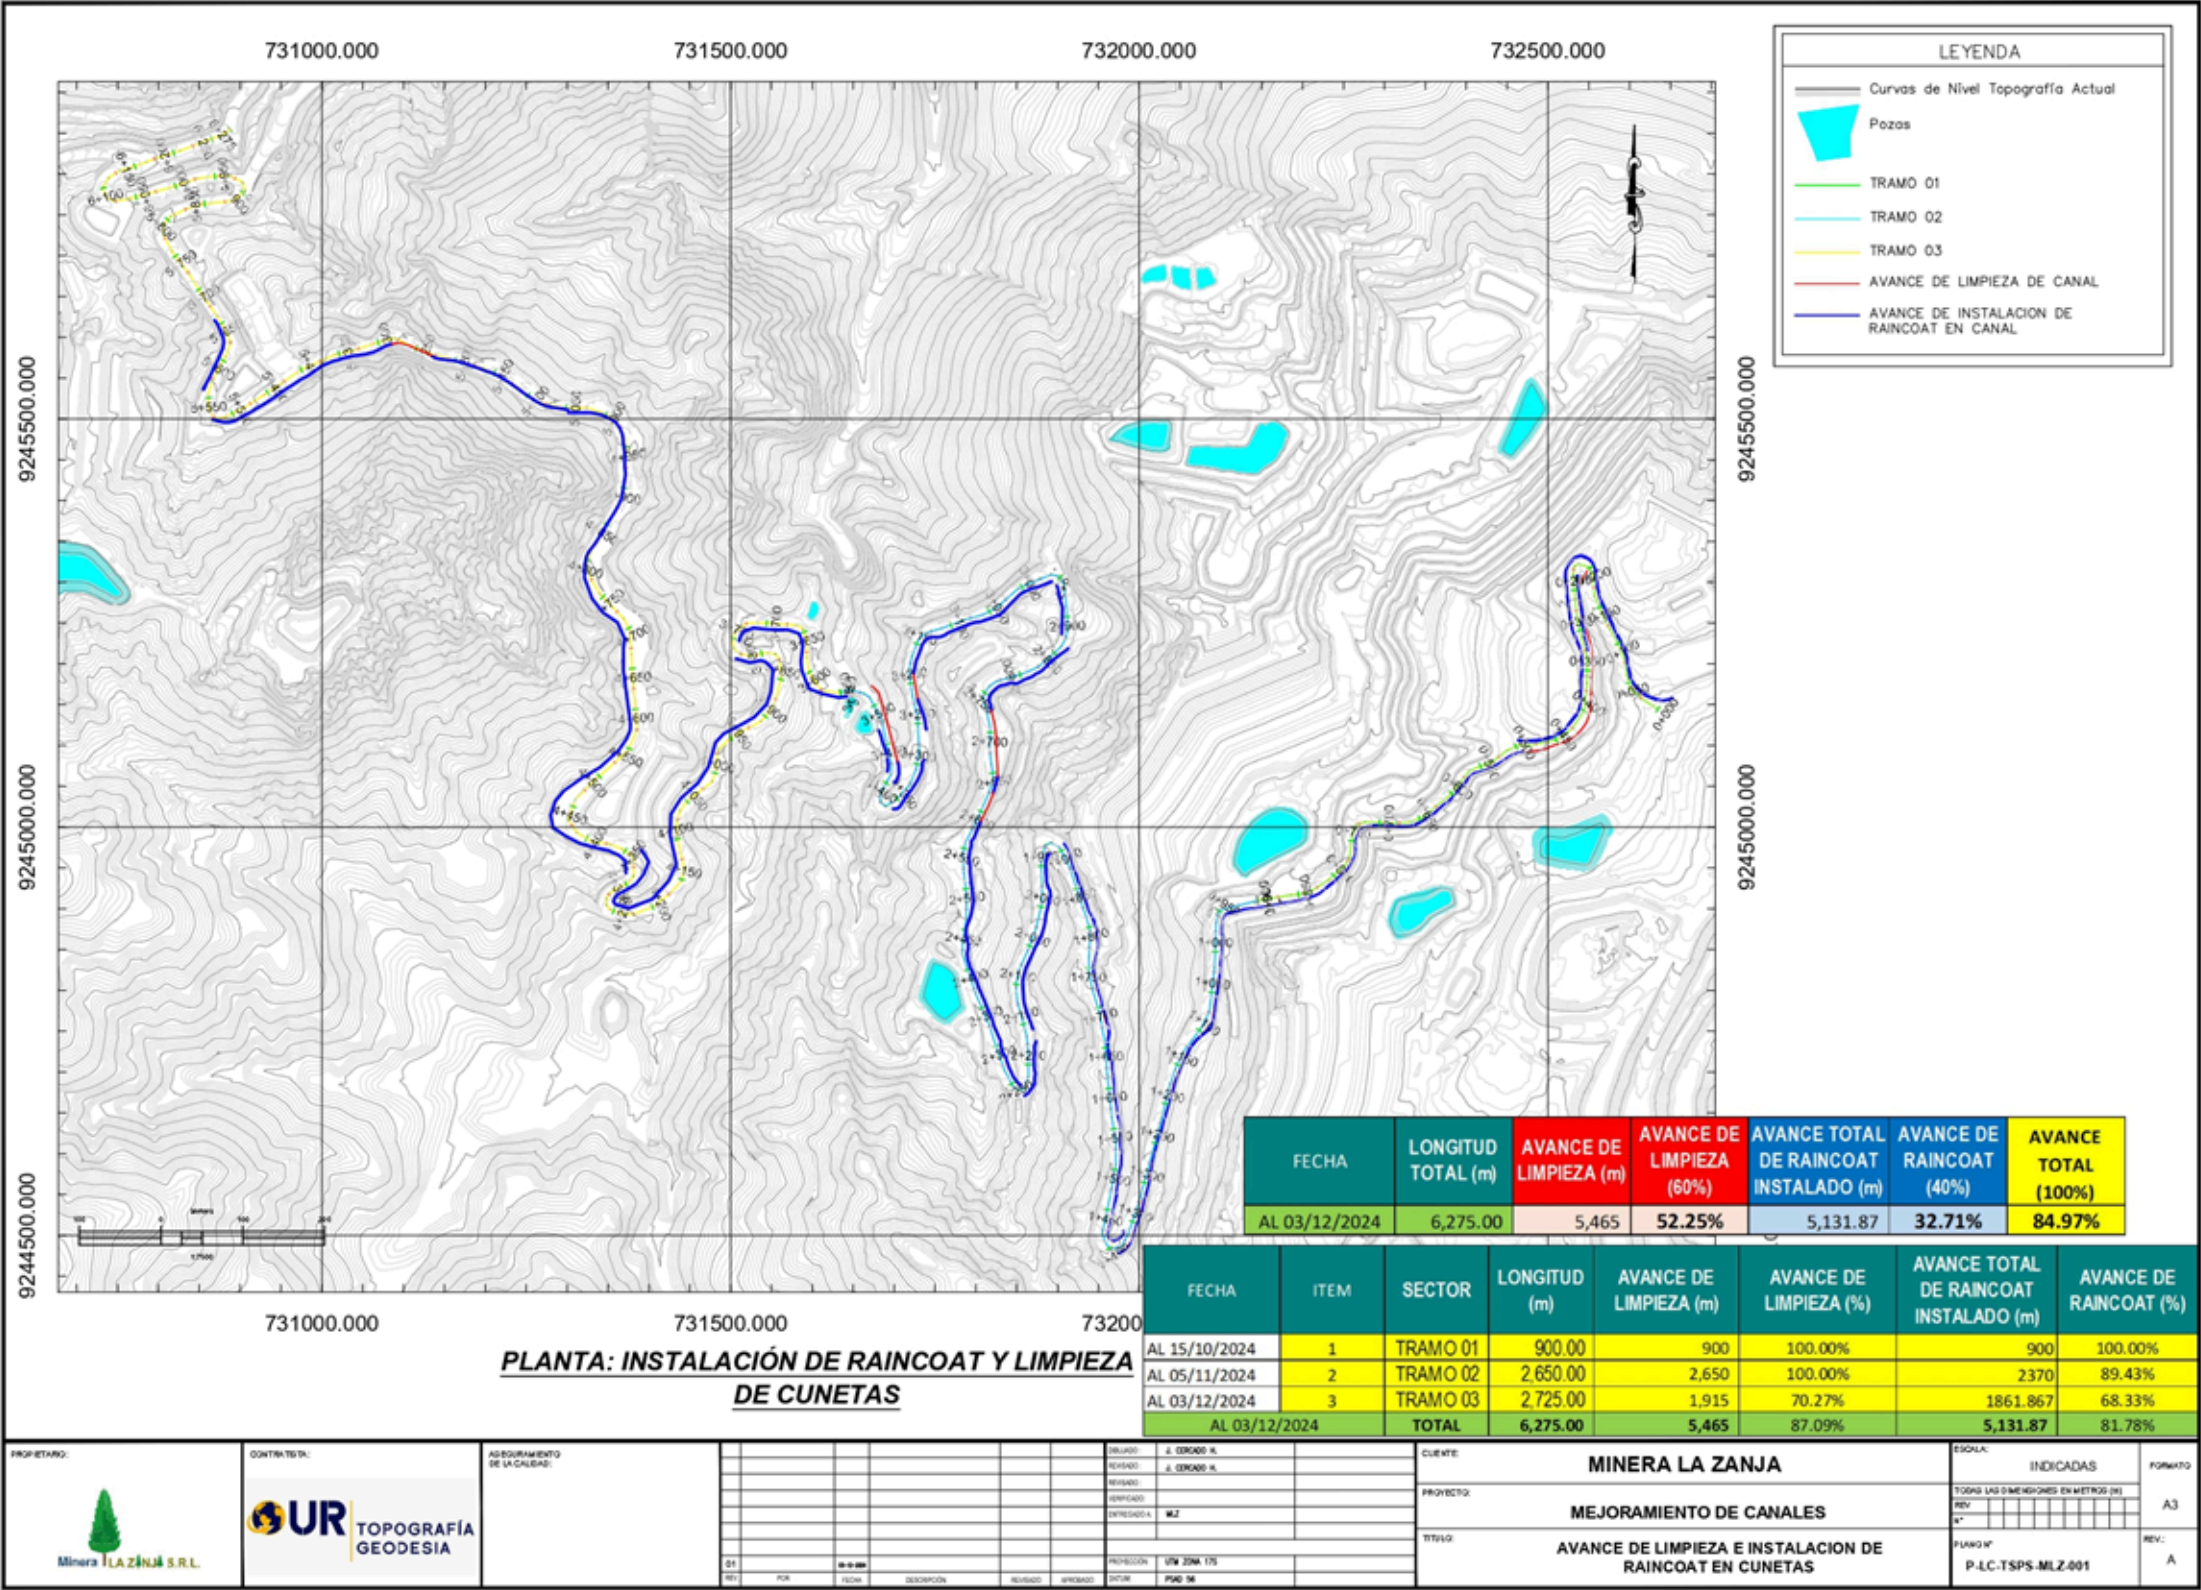
Channel lining with geomembrane.

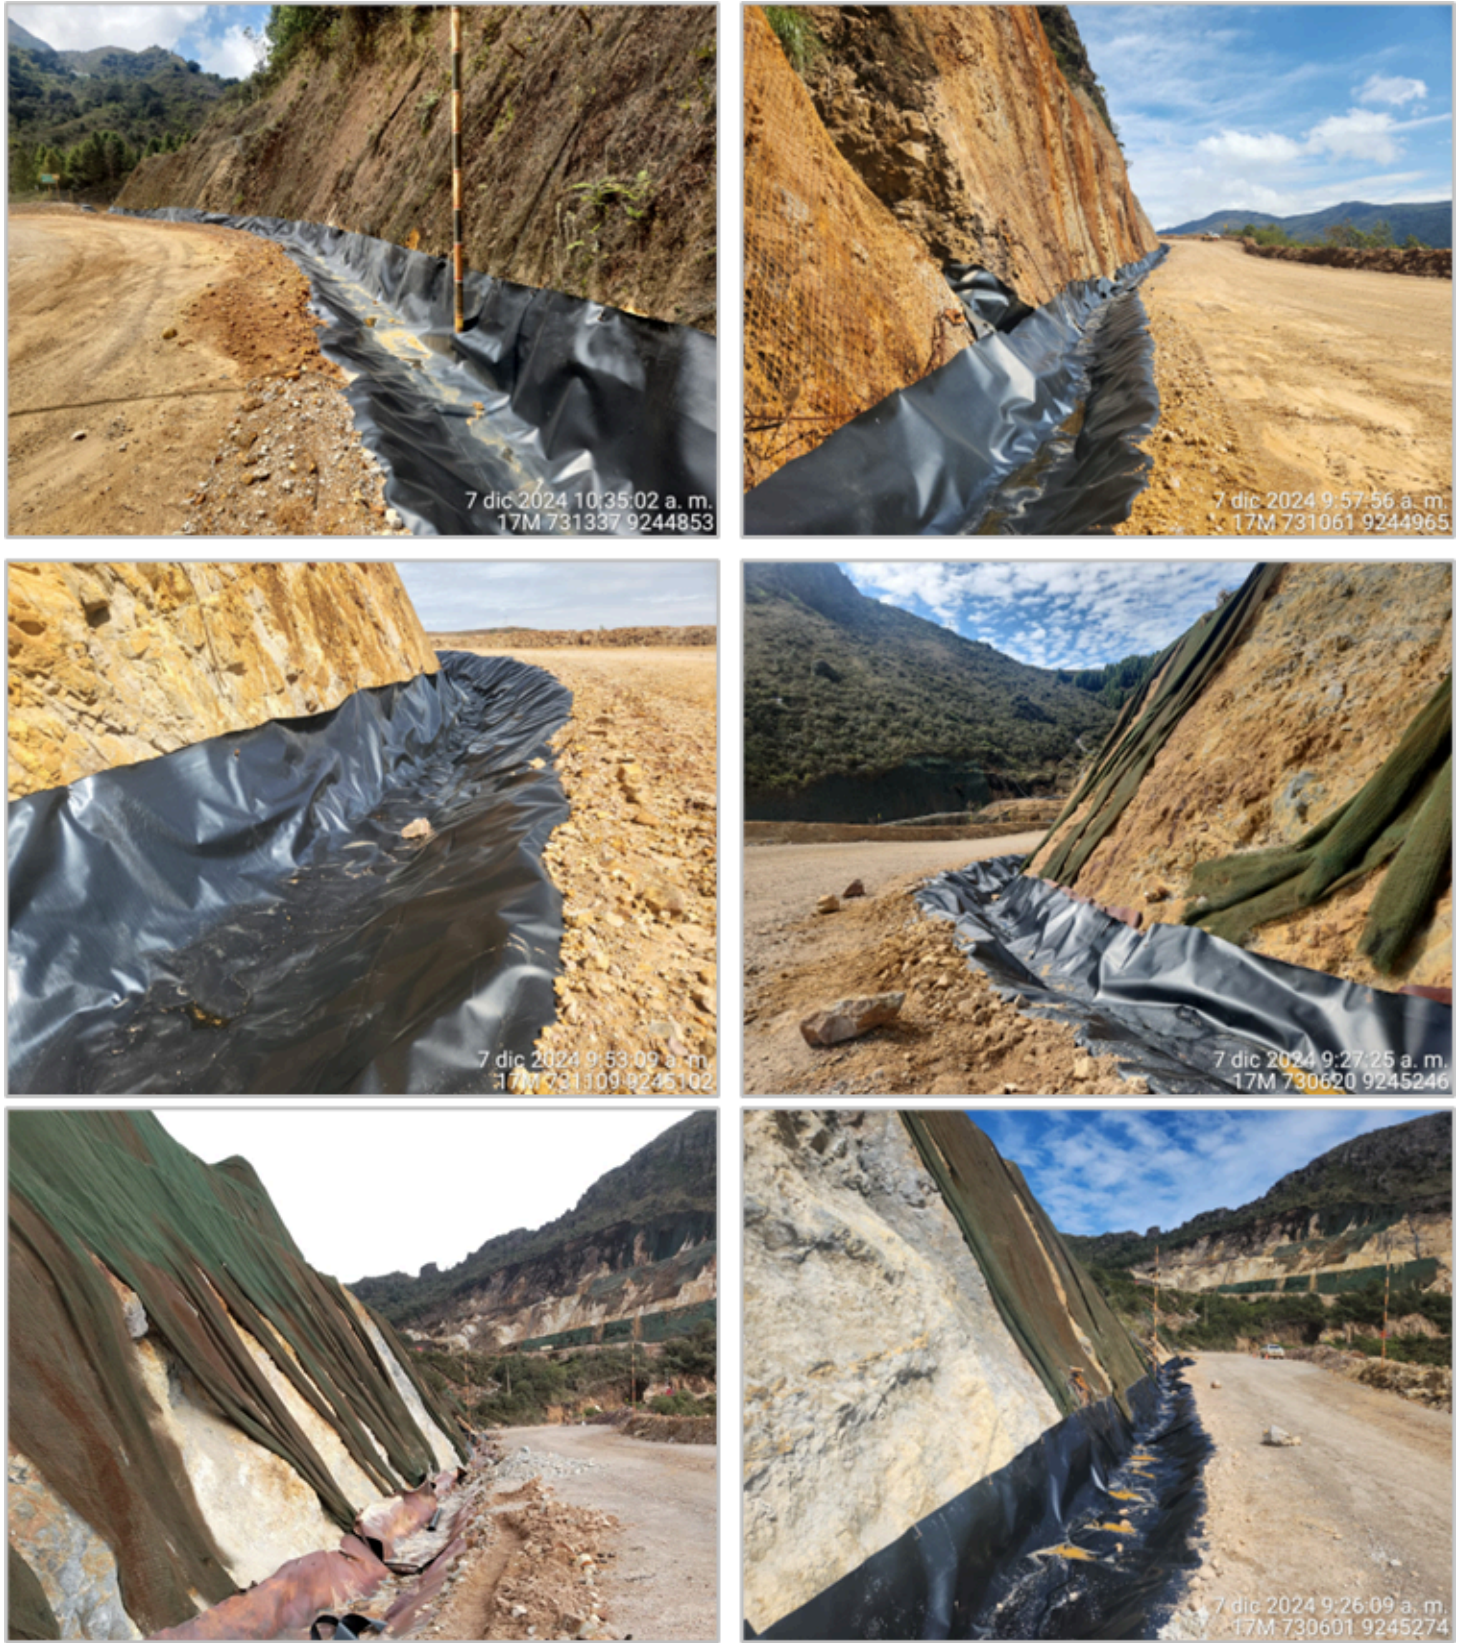
Progress of channel lining with geomembrane

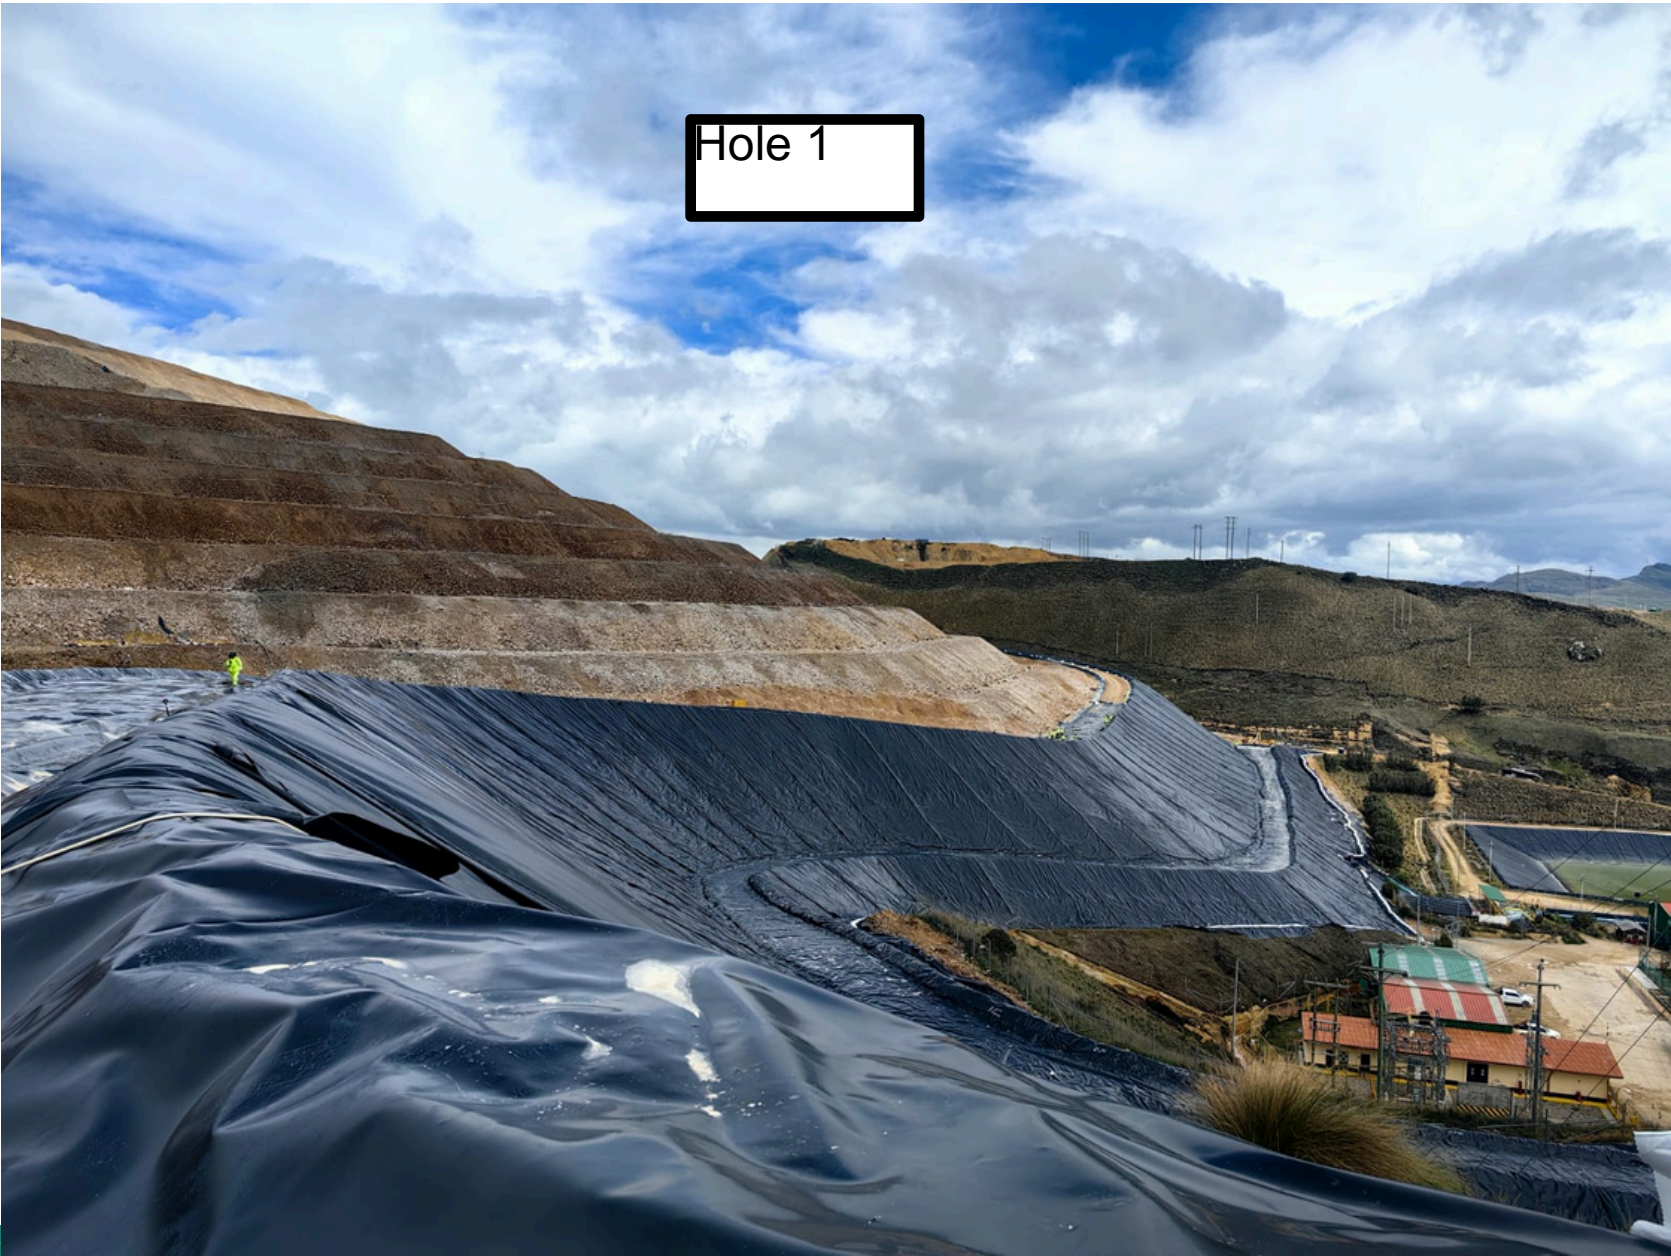
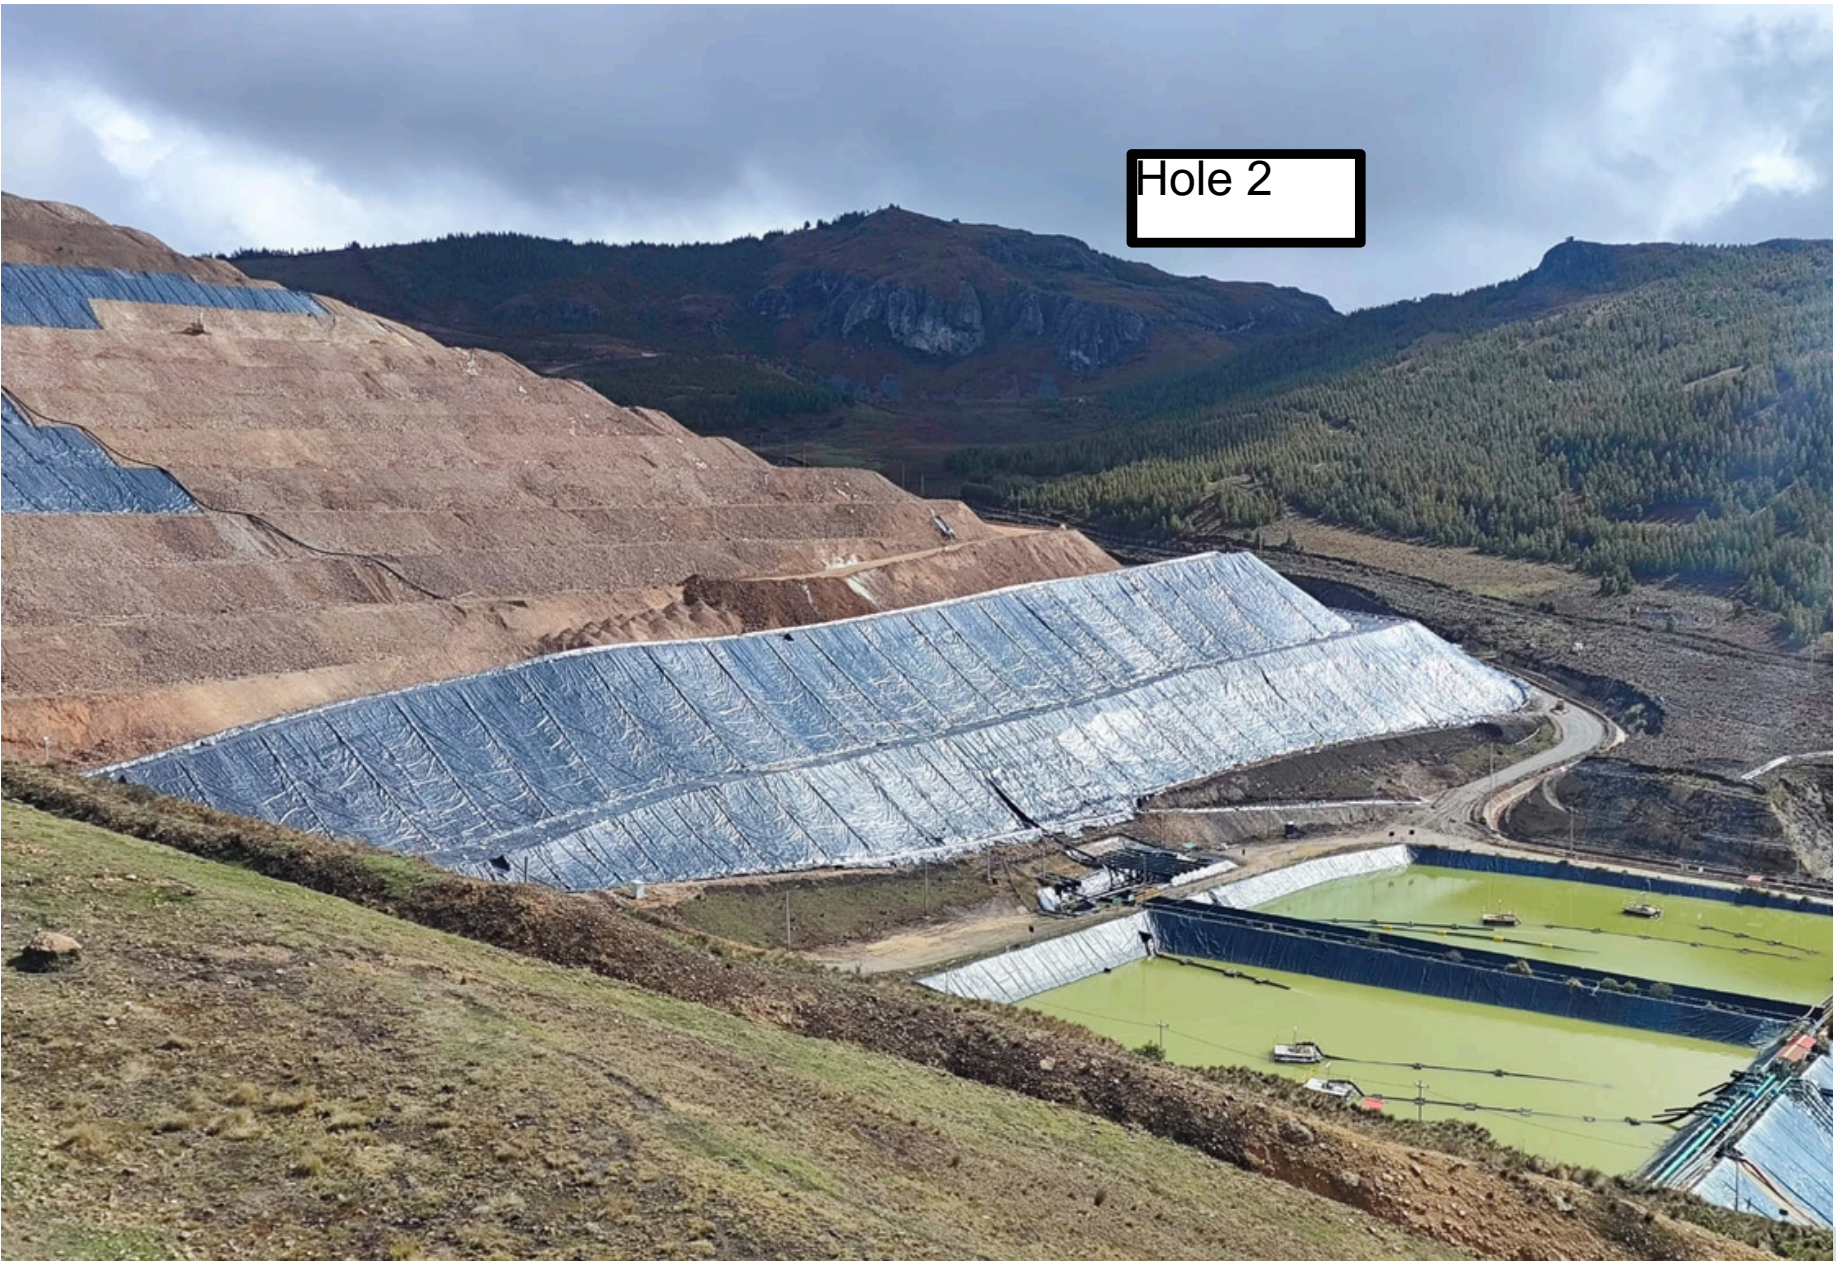
Geomembrane covering of the THY PAD dams - Hole 1 and Hole 2

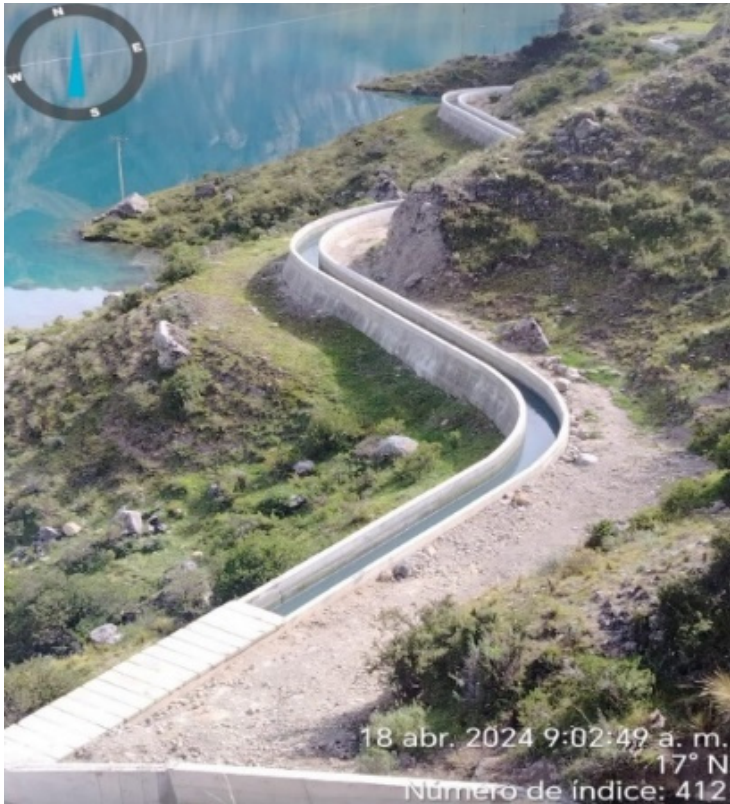
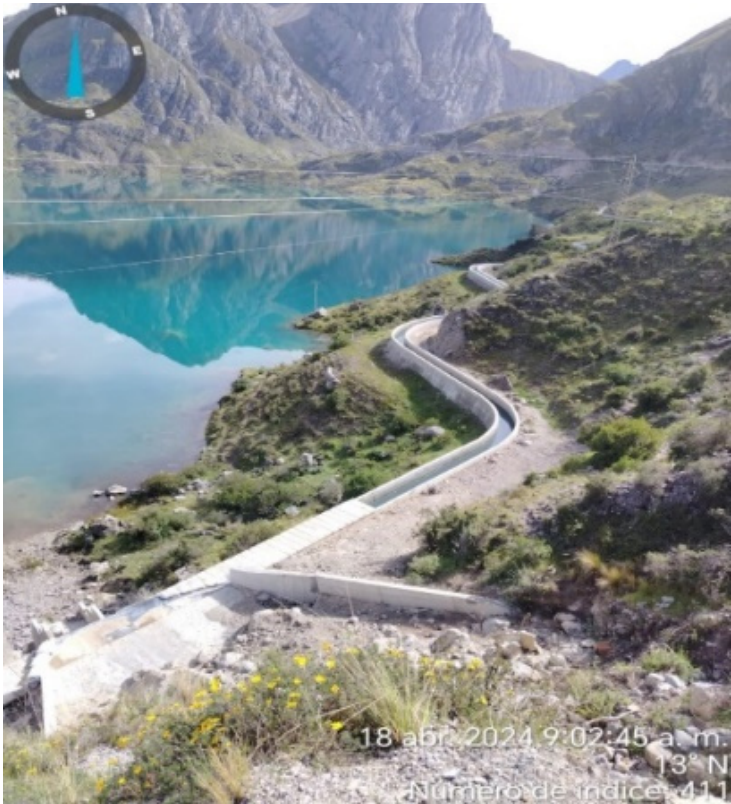
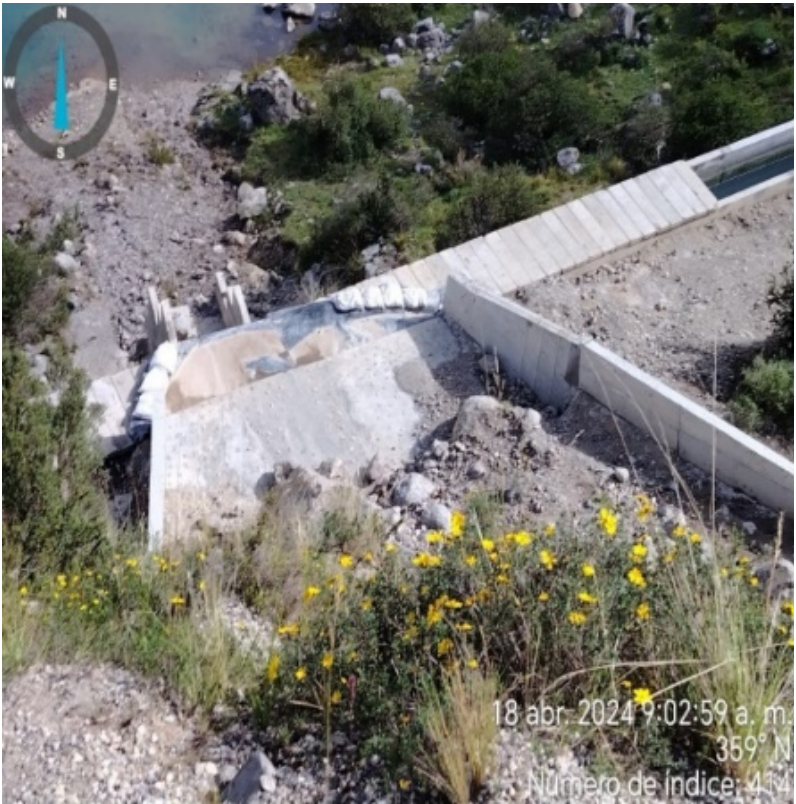
| STATUS ENVIRONMENTAL EVENTS LEVEL 3, HIGH POTENTIAL | | | | |
|---|---|---|---|---|
| Uchucchacua | There is evidence of overflow of treated effluent (Q=15 l/s) for approximately one hour, from the diversion channel that borders the Patón Lagoon towards the EU-20 discharge point. | 100% | 30/04/2024 | (+) Daily inspection of the channel in the wet season (Progress 100%)<br>(+) Identification of critical points of the diversion channel and cleaning of material (Progress 100%)<br>(+) Clearing of loose material on the slopes connected to the diversion channel (Progress 100%)<br>(+) Cleaning of the contact channel of the access road (Progress 100%) |

- Channel overflow 100%
